NATIONAL DAM SAFETY PROGRAM. ISCHUA CREEK WATERSHED DAM NUMBER --ETC(U)

REPORT DOCUMENTATION PAGE		READ INSTRUCTIONS BEFORE COMPLETING FORM
1. REPORT NUMBER	2. GOVT ACCESSION NO. AD-A105774	3. RECIPIENT'S CATALOG NUMBER
4. TITLE (and Subtitle) Phase I Inspection Report Ischua Creek Watershed Dam Site #1 Allegheny River Basin, Cattaraugus County, NY Inventory No. 583		5. TYPE OF REPORT & PERIOD COVERED Phase I Inspection Report National Dam Safety Program

**ISCHUA CREEK WATERSHED
DAM No. 1**

Ischua Creek Watershed
Dam No. 1

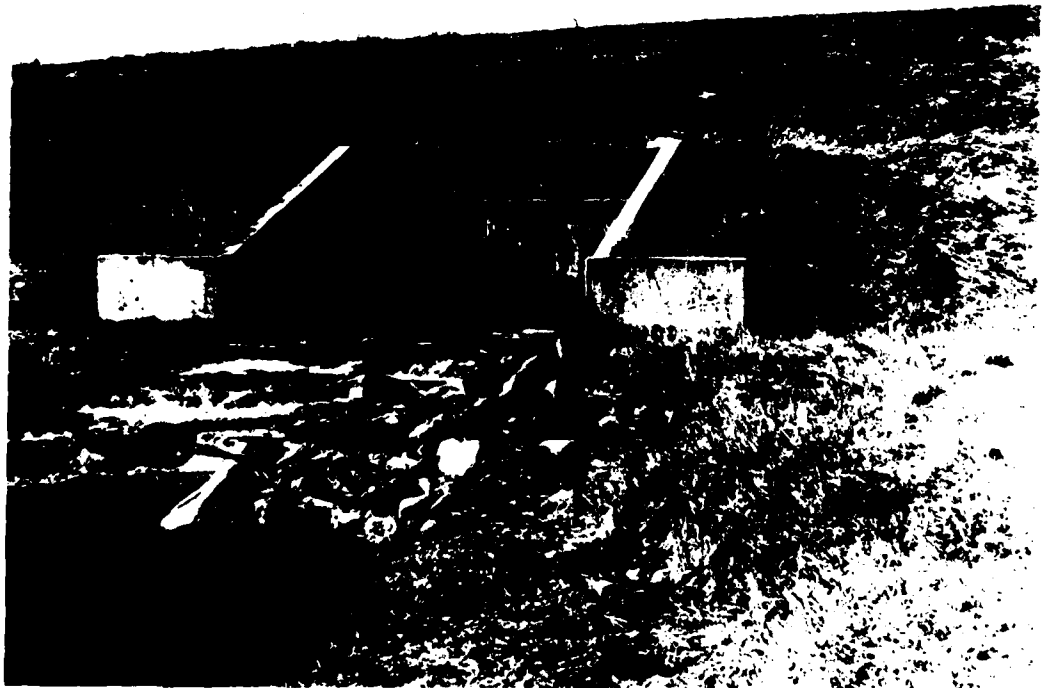
The structure is in good condition. Minor spalling was observed on the concrete baffle. Minor erosion behind both wingwalls were noted. There is a 5' x 14'1" opening between the inlet wall and baffle that presents a potential hazard to people.

4. Principle spillway impact basin.

- Place a grate over the opening in the impact basin between the inlet wall and baffle.
- The debris and vegetation should be cleared from the downstream channel, outlet basin, auxiliary spillway channel and embankment surfaces periodically. A program of periodic mowing and cutting of the embankment and outlet channels should be provided.
